Coastal cliff monitoring using UAS photogrammetry and TLS

A peer-reviewed paper by THOMAS P. KERSTEN, MAREN LINDSTAEDT and KLAUS MECHELKE

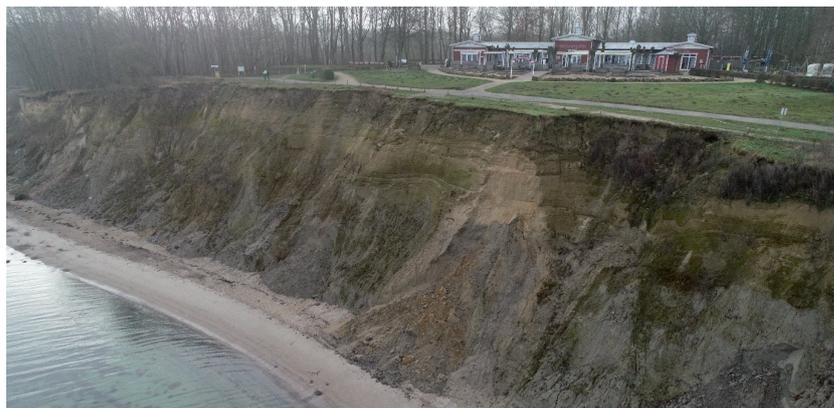
Fig. 1: The coastal cliff at Brodten with the Hermannshöhe restaurant in the background, photographed from the DJI UAS on 20 January 2020

outline of the current Baltic Sea coast (Schmidtke 1992). The coastline, in places up to 20 m high, is in large sections still an active cliff. It recedes on average up to one metre per year due to the erosive action of waves generated by east-northeast winter storms, heavy rainfall with the accompanying softening and washing out of sediment layers, as well as freezing seepage water spreading in volume. In the immediate vicinity of the steep bank is the restaurant Hermannshöhe, built before the First World War and replaced by a new building in May 2012, which is a popular destination for tourists. The HCU Hamburg carried out coastal cliff monitoring with terrestrial laser scanners in Hermannshöhe section (Fig. 1) between 2004 and 2016 in order to document the changes and landslides. In 2016 the steep coast was surveyed with a UAS for the first time (Kersten and Lindstaedt 2017) followed by a second survey with the same UAS in 2018 (Kersten et al. 2019). Fig. 1 shows the investigation area at the Brodten cliff with the restaurant building in the background, located some 52 m from the edge of the cliff (status January 2020).

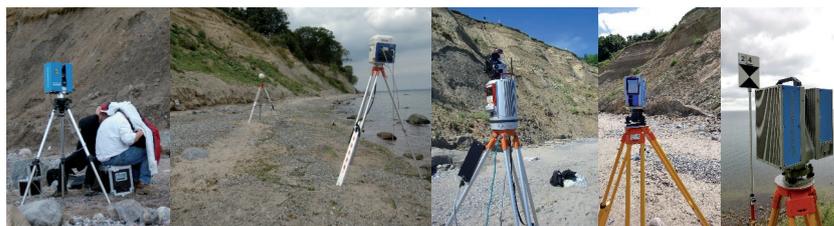
Fig. 2: Terrestrial laser scanning at the coastal cliff of Brodten – Z+F IMAGER 5003 (2004), Mensi GS100 (2005), Riegl VZ-400 (2010) and Faro Focus3D X330 and Z+F IMAGER 5010 (2016)

Different terrestrial laser scanning systems were used for the documentation and monitoring of the Brodten cliff section over twelve years (Fig. 2 and Table 1).

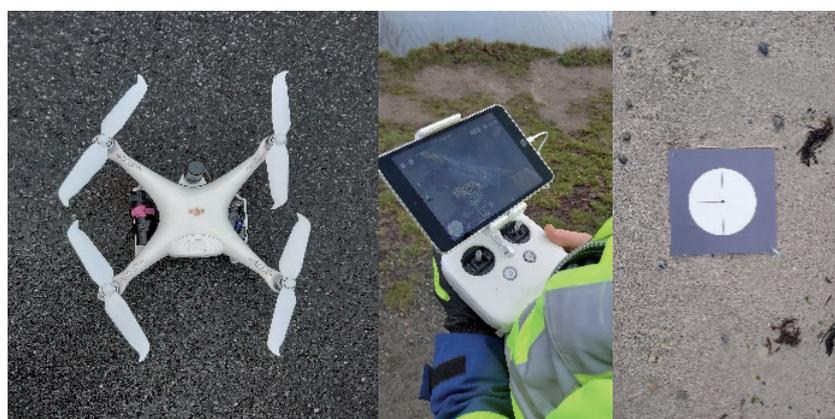
Fig. 3: DJI Phantom 4 Pro KlauPPK (left), remote control with Apple iPad (centre) and signalised ground control point (right)

including remote control and signalised ground control points, is illustrated in Fig. 3. The central component of the KlauPPK hardware is the multi-channel multi-frequency GNSS receiver of NovAtel. The KlauPPK software provides sophisticated PPK data processing to determine the precise coordinates of the projection centre of each image taken in the requested coordinate system.

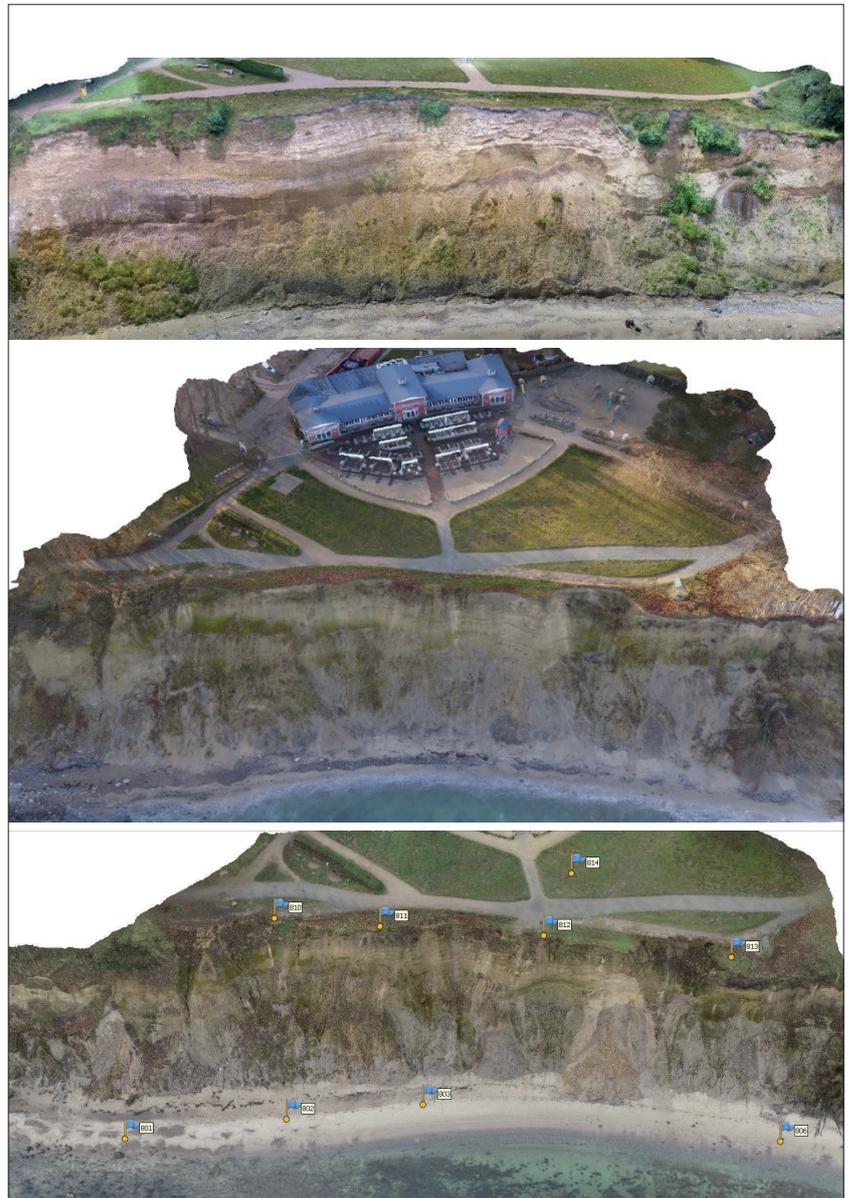
Fig. 4: 3D meshed models of the Brodten Cliff derived from UAS-based aerial imagery – June 2016 (top), December 2018 (centre) and January 2020 (bottom) including the configuration of nine ground control points (yellow dots with blue flags)

signalised control points in the respective images of each aerial flight. The configuration of nine GCP for the aerial flight in 2020 is illustrated in Fig. 4 (bottom). During each aerial UAS flight, a very high overlap of more than nine images per area could be achieved for all photogrammetric blocks.

segmented. For the reduced point cloud, PhotoScan/Metashape calculated a triangular mesh in high resolution, which represents a digital surface model (DSM). Fig. 4 shows the three generated 3D surface models of the cliff after texture mapping using the colour images.
